# BLM Legacy Wells

Environmental Hazards

&

Eyesores

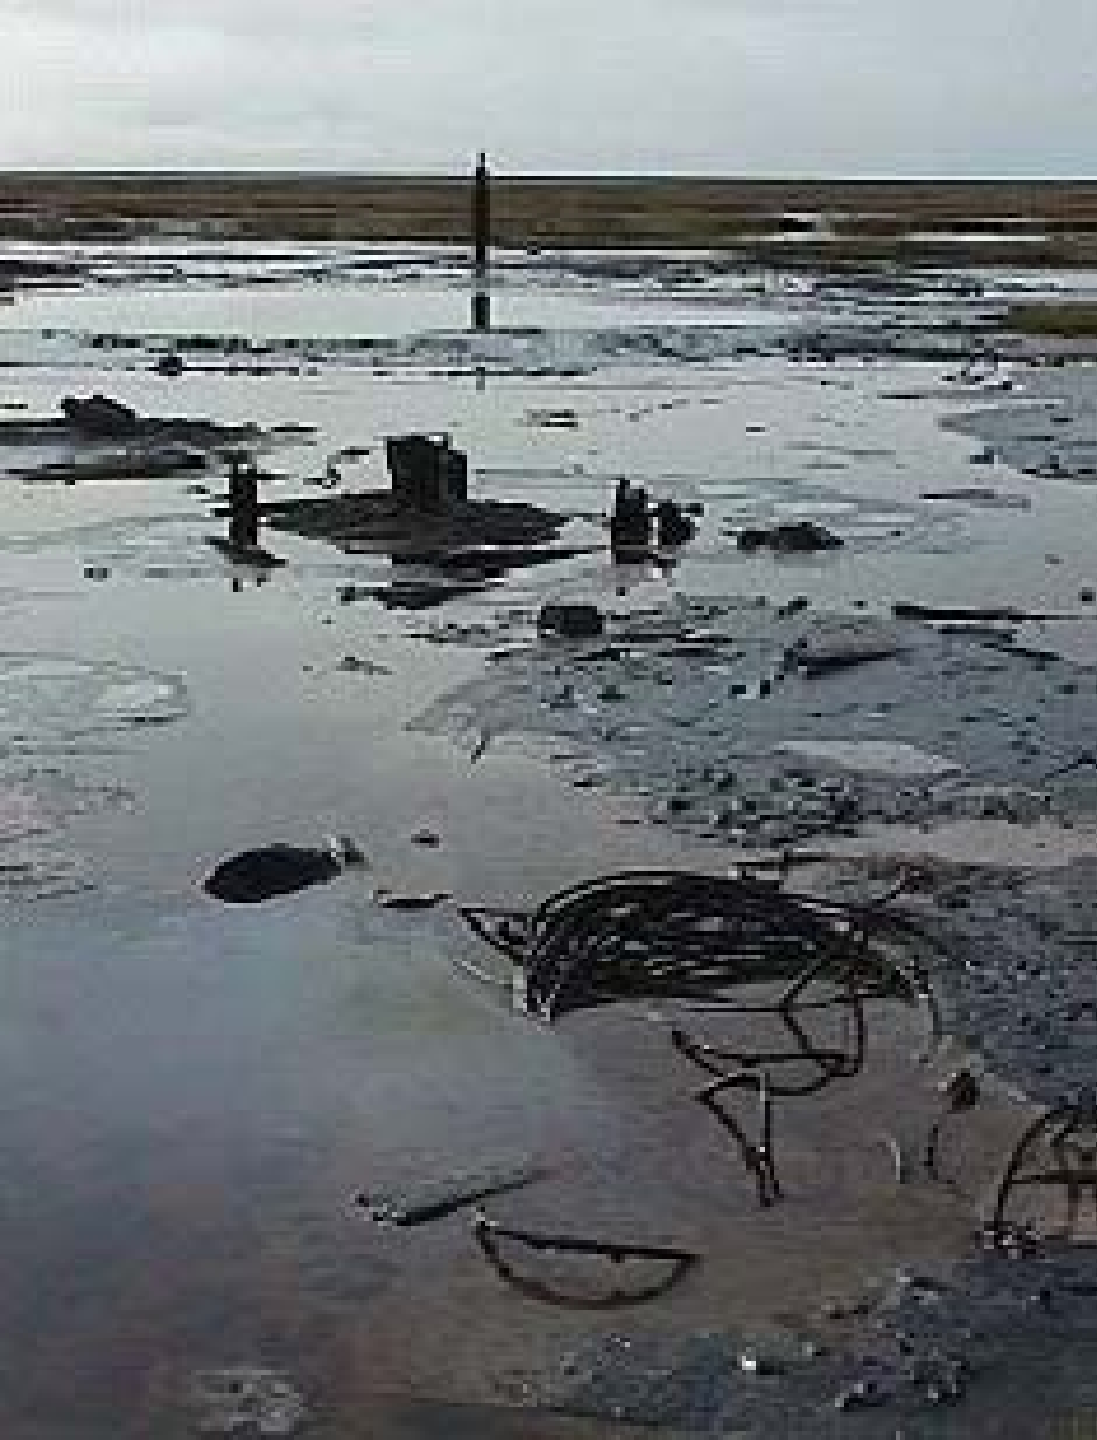
Wellhead along with  
wood and metal debris  
in a natural oil seep

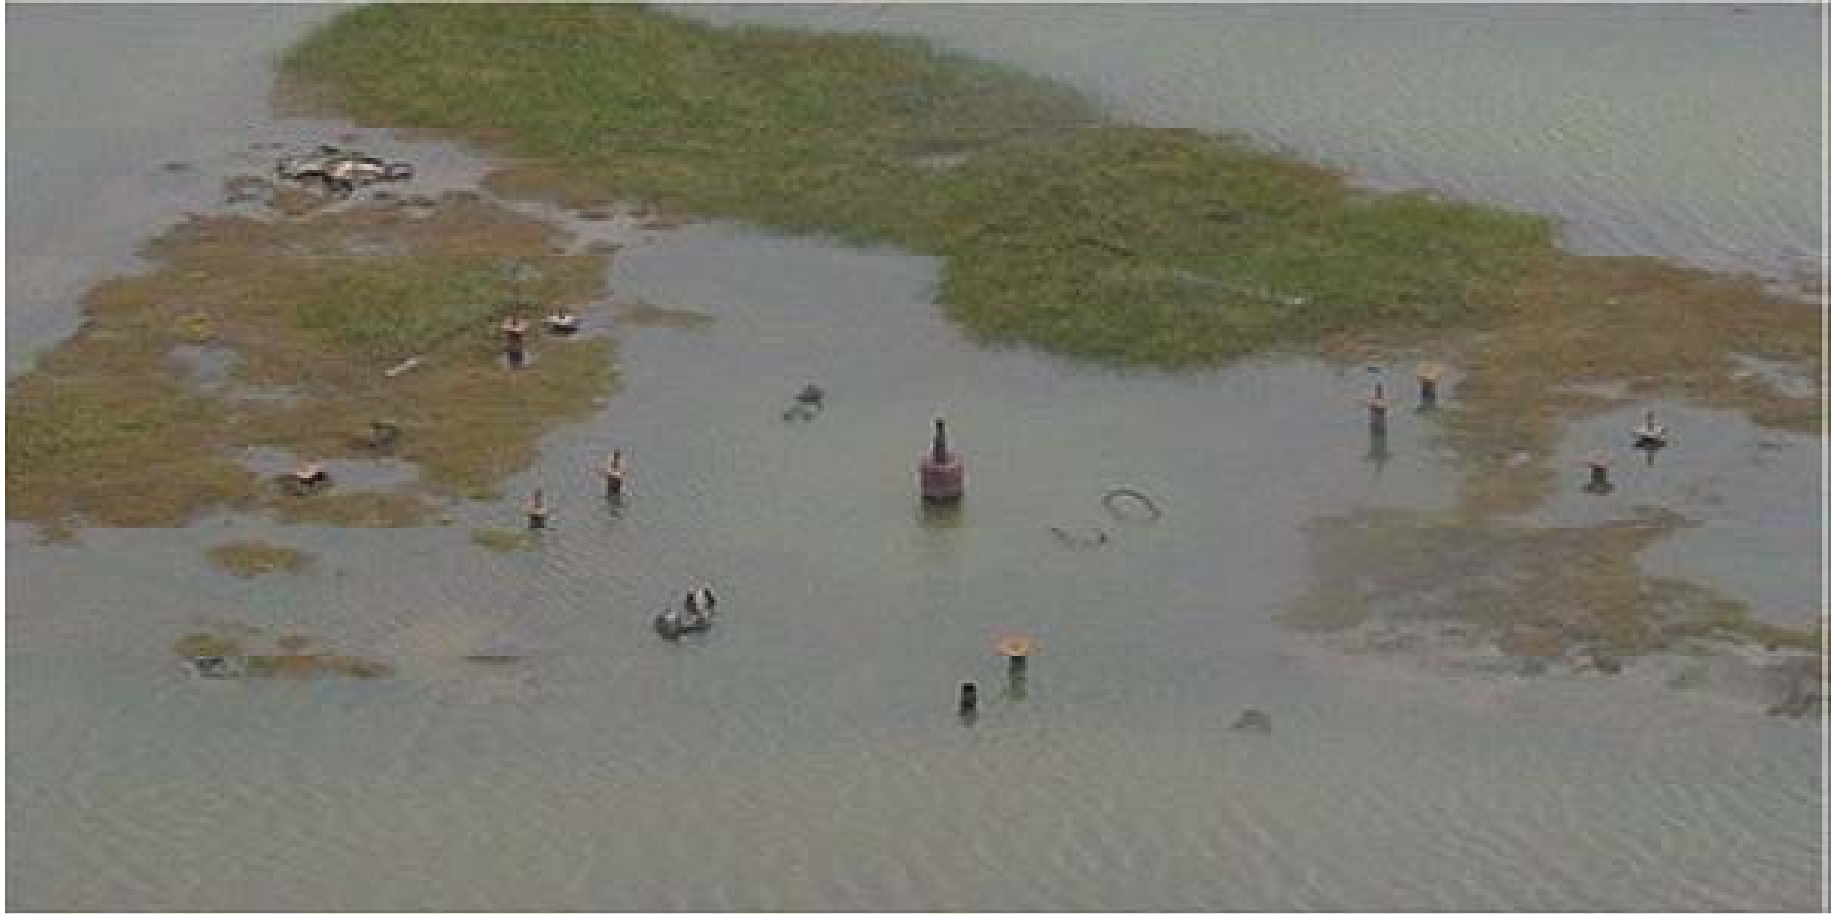
Natural subsidence and snowmelt have started to obscure this site.

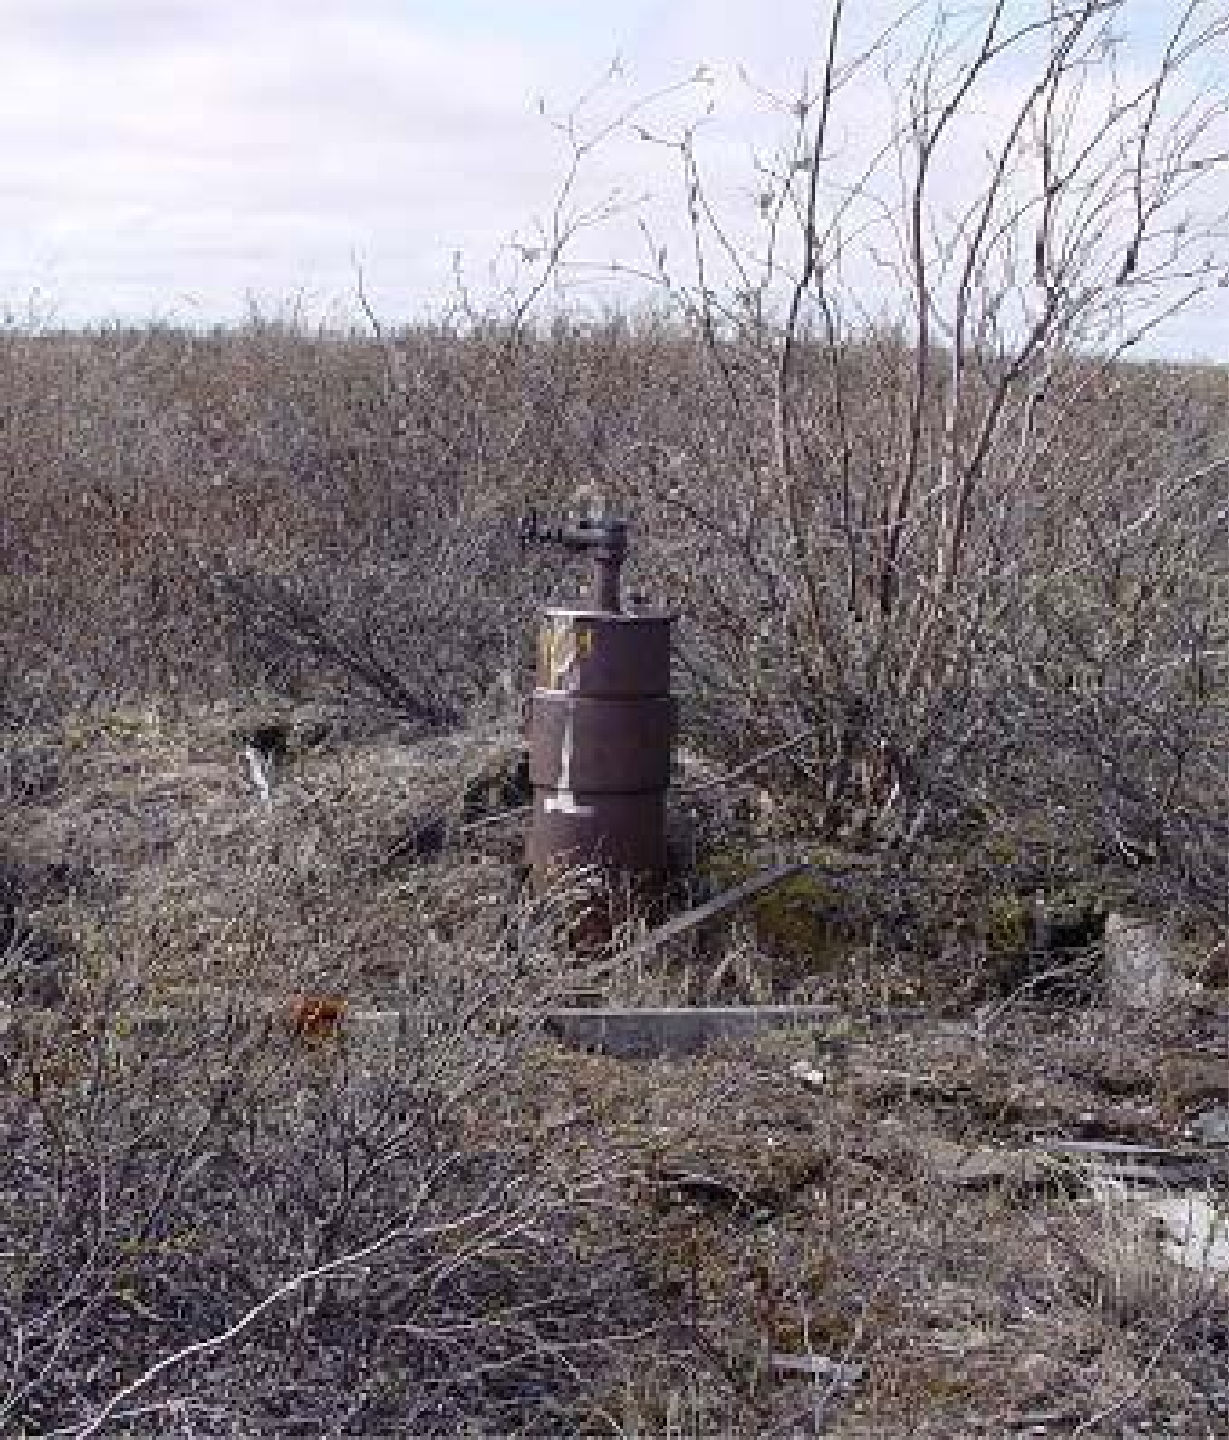
Primitive, rusting wellhead  
and wood debris
