Case Studies:

Evaluating Well Integrity with Multi-Arm Caliper and Magnetic Resonance Logs

Monte Markley, P.G. September 29, 2020

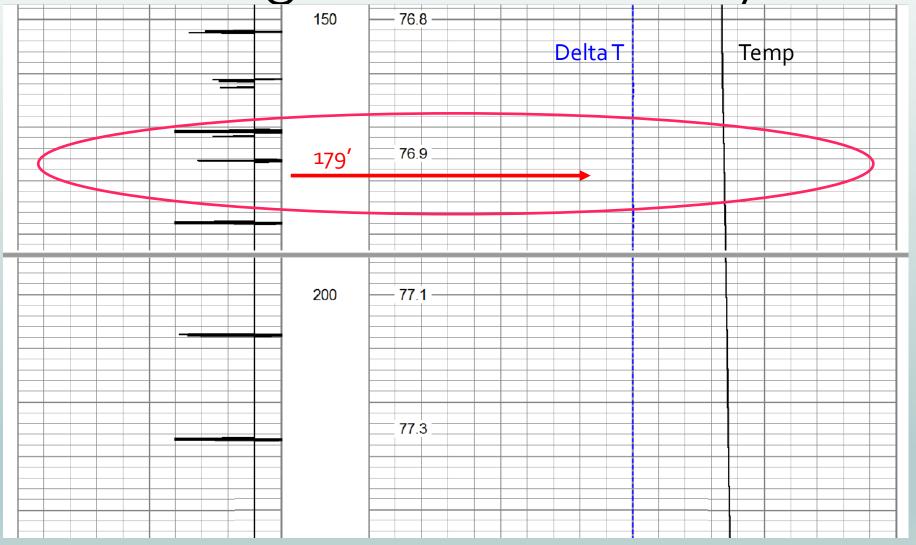
Well Passed Temperature and Pressure MIT's

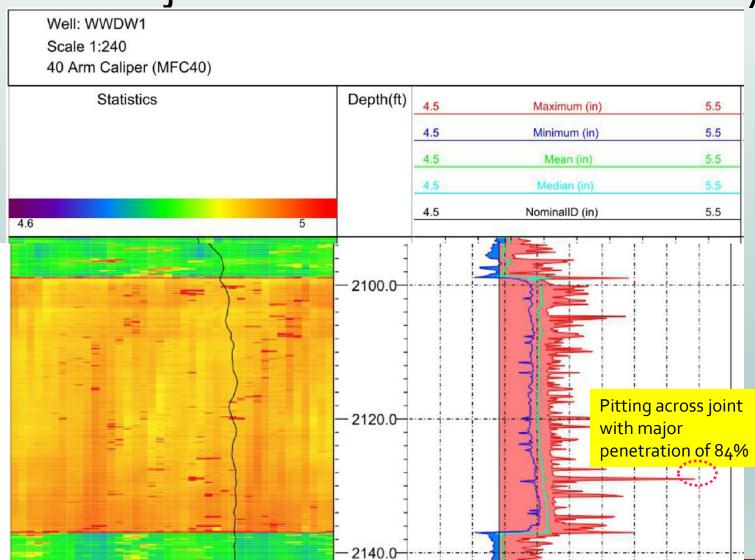
- Suspected small tubing leak
- Evaluated with tubing in well
- 7,850 ft of 5 ½" tubing
- Within 9 5/8" longstring
- Provide owner options

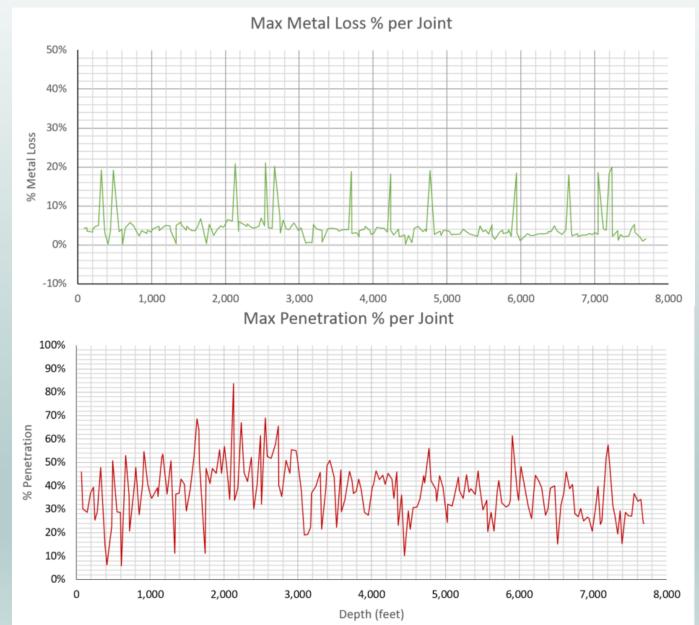
- Only 1 leak in tubing
- Overall, the tubing string in moderate to poor condition
- Patching is only postponing the inevitable
- Replace the entire tubing string
- Longstring casing in good condition

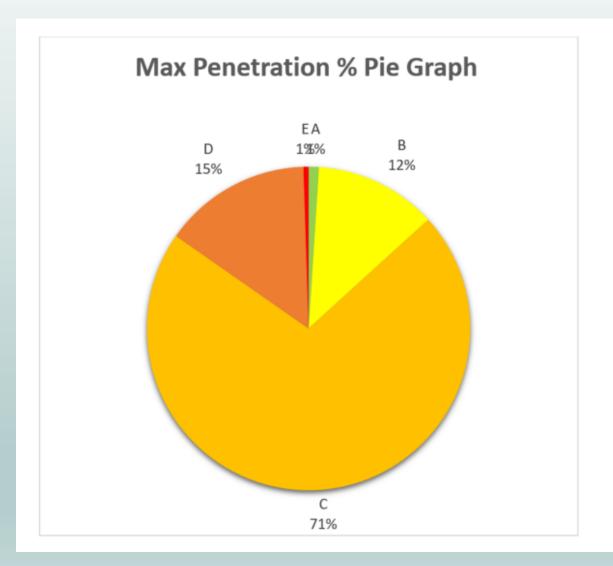
Grade	Joints		
Α	2		
В	24		
С	140		
D	29		
Е	1
